⑨ BUREAU OF SHIPS GROUP
TECHNICAL INSPECTION REPORT

⑥ OPERATION CROSSROADS.
U.S.S. NIAGARA (APA87).

TEST BAKER [U] ⑧

USS NIAGARA (APA87)

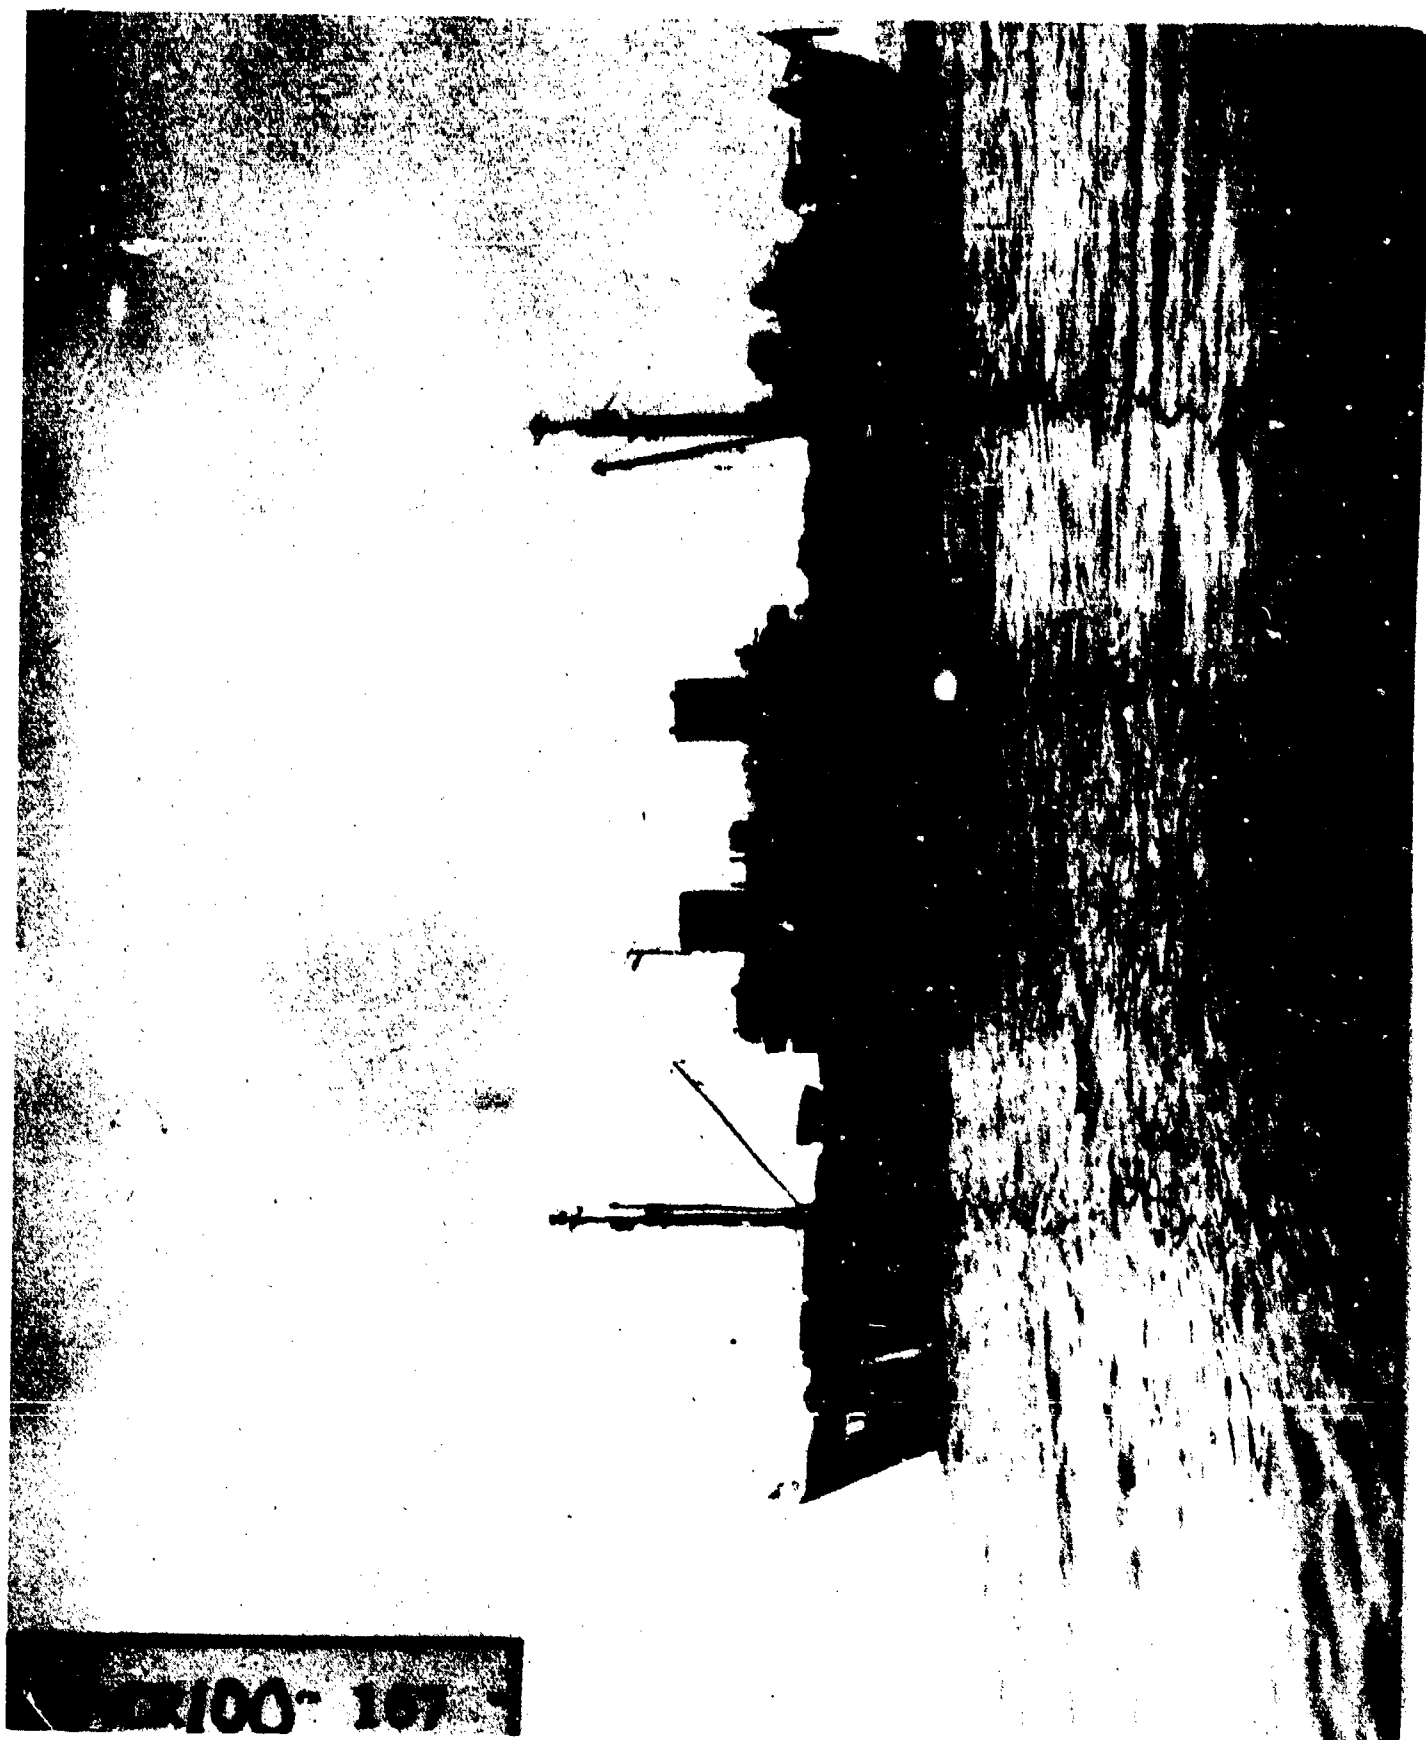
There is no damage. The only effect of the test is the displacement of several hatch cover panels. A general view of the ship after the test is on page 30.

AB-CR-100-167-2. View from off port beam after Test B.

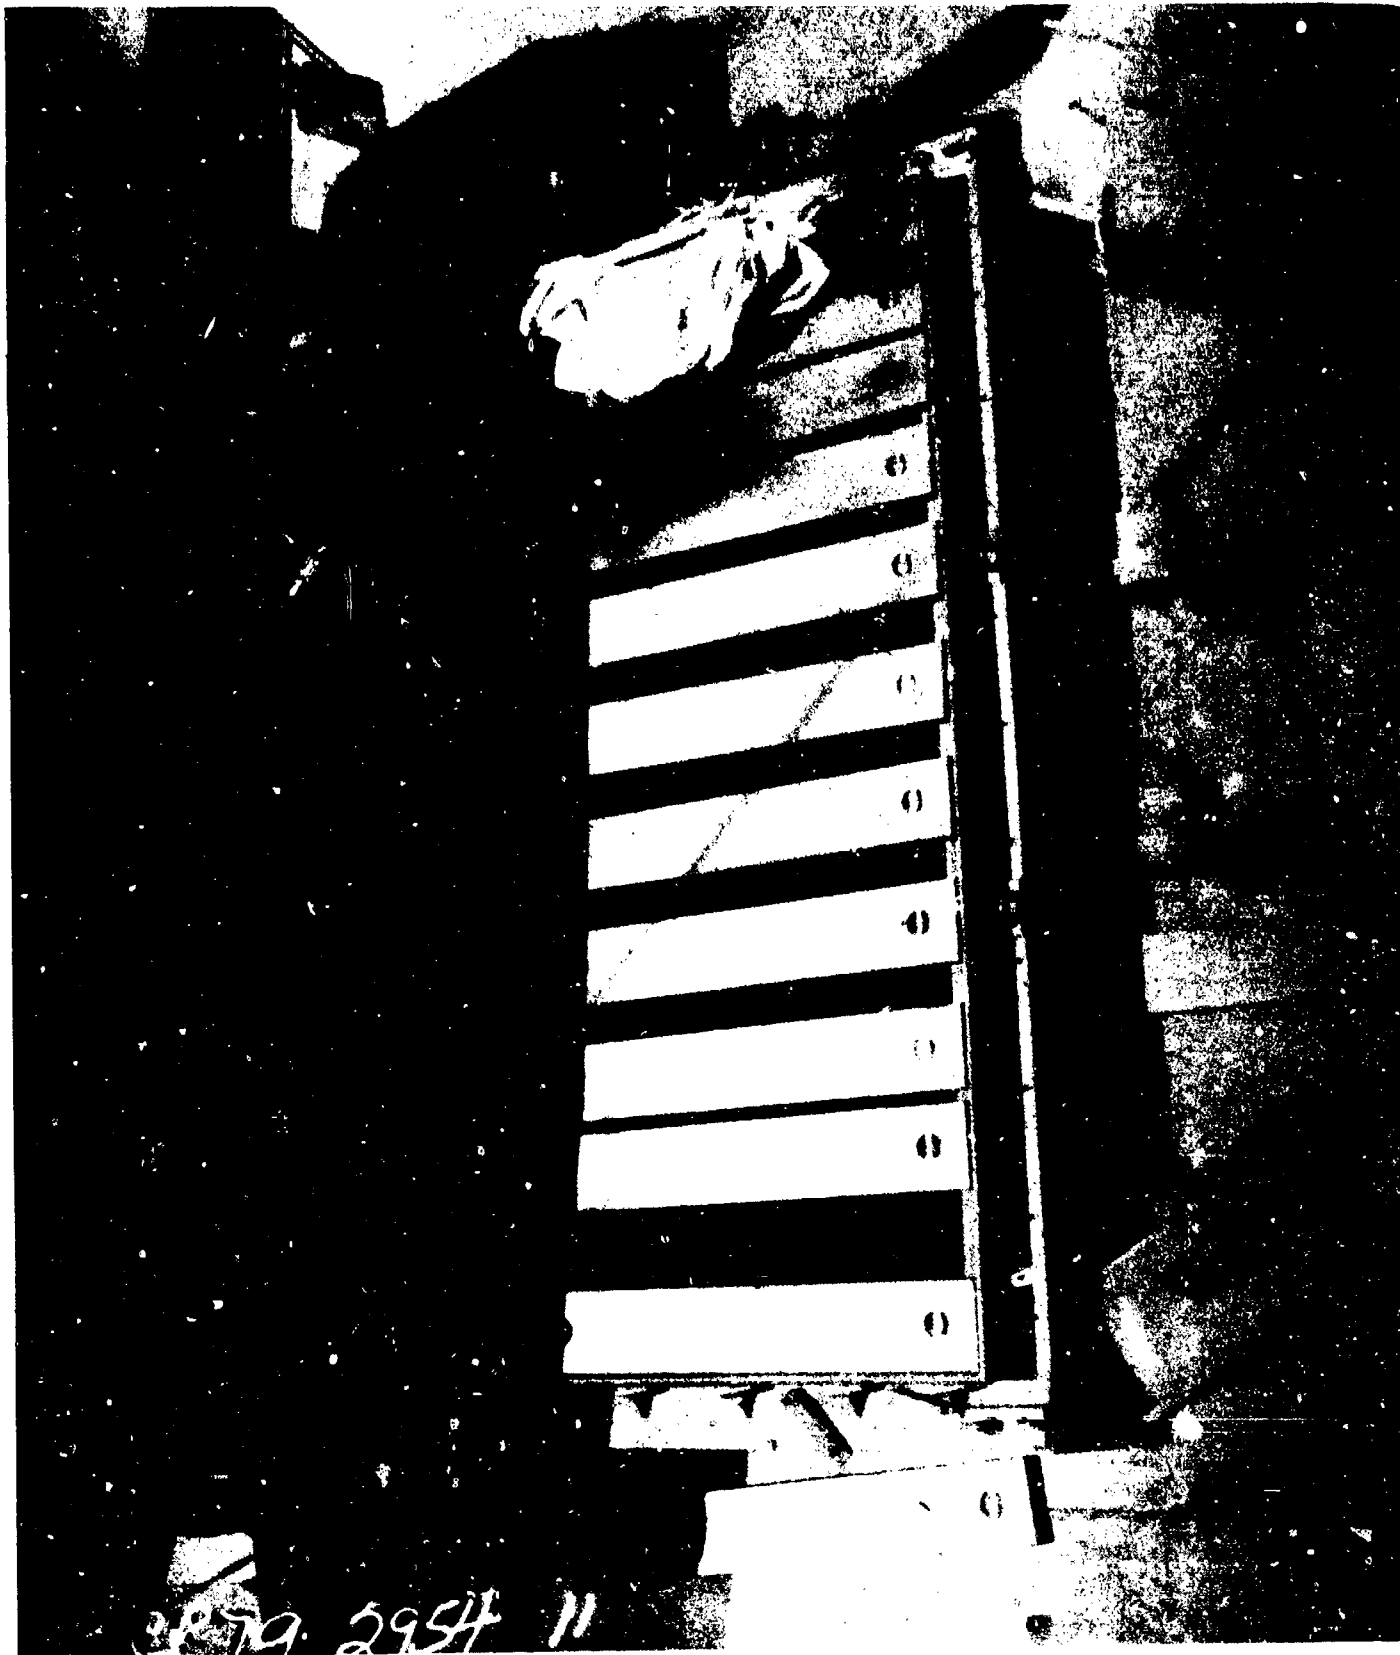
No damage. About four metal sections of the upper deck covers of both cargo hatches were displaced and fell to the main deck. (Photos 2954-10, 11, pages 31 and 32).

AB-CR-79-2954-11. Looking forward at displaced cover panels on forward cargo hatch.
